Tim Standish  
Electro-Motive Diesel, Inc.

George King  
New York Susquehanna and Western Railroad

LMOA Mechanical Committee

### EMD Turbocharger Change out Best Practices

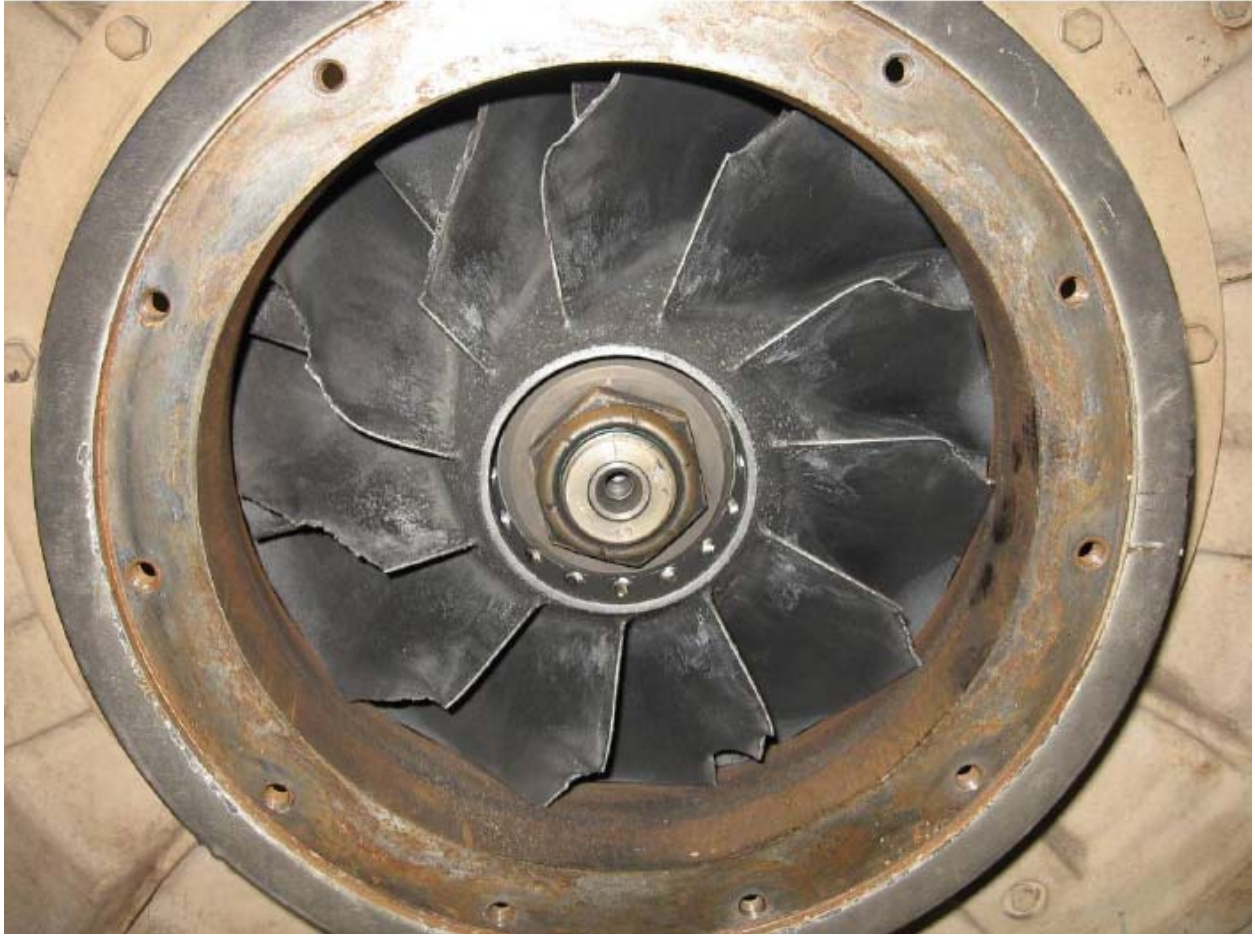
To conduct an air inlet inspection, remove the rubber air intake boot and flange and inspect the impeller for broken or nicked vanes due to foreign material (see figure 2) or any visible signs or rubbing. Foreign material damage to impeller can be due to debris being left in the filter housing from a previous turbocharger failure and being drawn into the new turbo. Damage can also occur if there is a misapplication of the compressor inlet boot in which the boot may travel and a clamp may enter the impeller and destroy it. If there is damage to the impeller the turbo needs to be replaced, the air filter housing cleaned out, and the air intake filters replaced. Inspect the aftercooler ducts and cores for debris as pieces of the impeller may enter the air duct and damage the aftercoolers. Also inspect for impeller rubbing which is often caused by an unbalanced condition within the turbocharger and can be detected visually or by excessive movement of the impeller. Unbalance conditions are often due to a turbine bearing failure which rarely occurs without an external contributing input. Therefore the turbocharger should be inspected for other defects prior to application of a replacement turbo such as damage to turbine blades or a lack of lubrication. If no damage is observed on the turbine blades the lube oil flow needs to be confirmed after installation of the replacement turbo prior to returning the engine to service; this will be covered in the installation section.

Figure 2 Impeller damaged due to foreign material ingestion

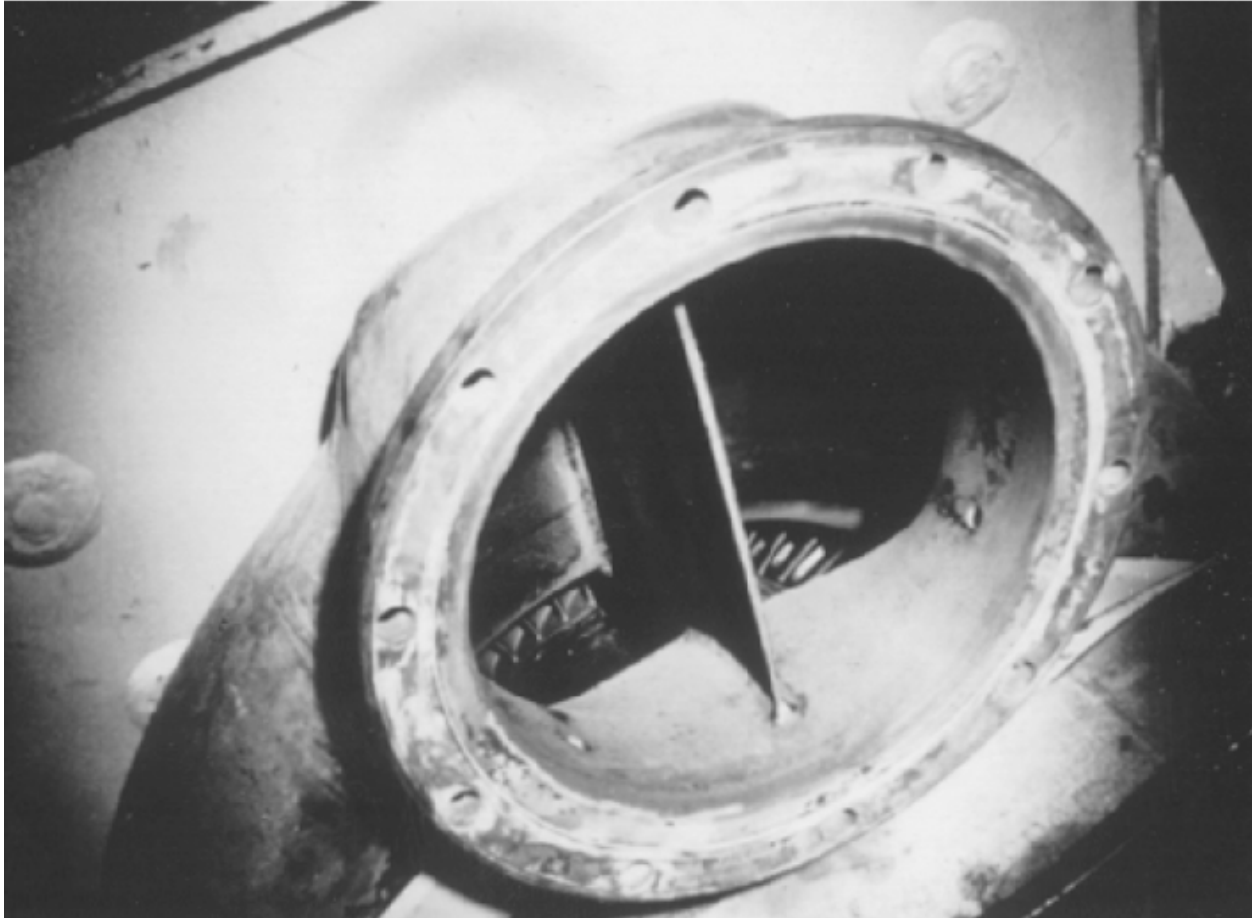
Inspection of the exhaust inlet (turbine inlet scroll) is conducted by removing the expansion joint and adapter/screen assembly and inspecting the leading edges of the blades and nozzle ring for damage through the nozzle between the 1:00 and 2:00 o'clock positions (see figure 3 and 4). Foreign material damage is generally in the form of small pieces of broken piston rings or exhaust valves that make it through the turbine inlet screen. It is recommended that whenever foreign material damage is observed in the turbine section that the turbo be removed prior to running it to destruction thereby increasing its repair cost. The power assemblies need to be inspected for damage such as broken piston rings, dropped valves, and scuffing. The screen must be removed and inspected for damage along with using magnetic particle inspection to check for cracks. The trap in the adapter/screen assembly (if equipped) must be cleaned out. The rest of the exhaust manifold should be inspected to ensure no other foreign material is present. The nozzle ring should also be inspected for deposits forming on the openings which indicate an engine problem such as a cooling water leak. Restriction of gas flow created by dented or plugged nozzles can cause the turbo to surge or "burp" at higher engine speeds therefore, inspect for internal water leaks.

Figure 3: Turbine blade inspection through exhaust inlet scroll

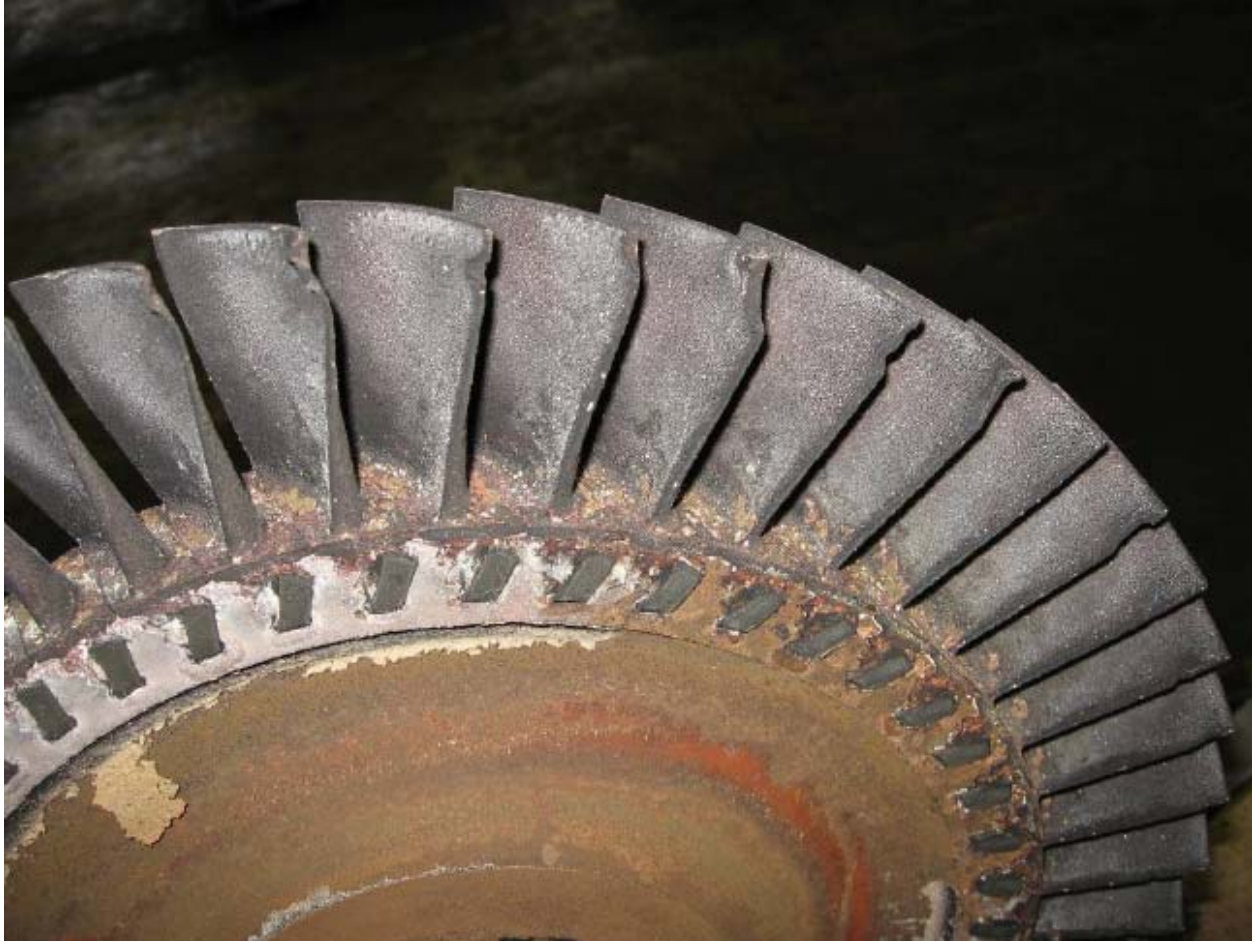
Figure 4: Foreign material damage to turbine wheel

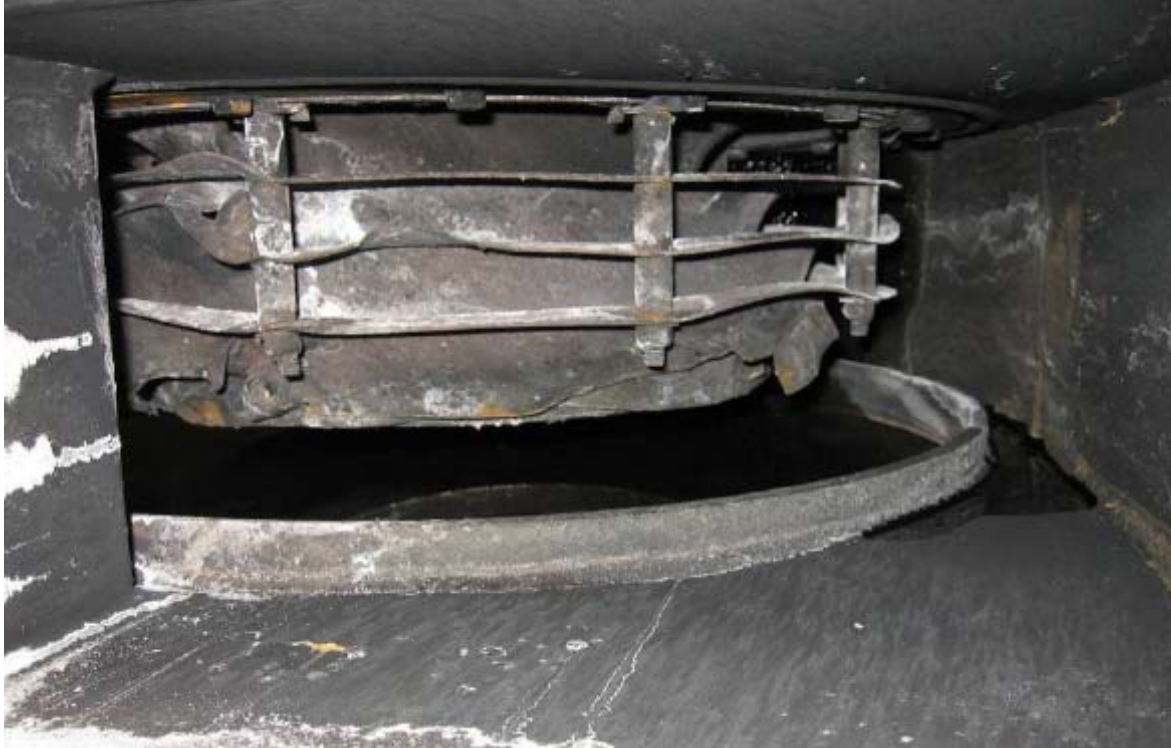
Next inspect the exhaust outlet for a warped diffuser, oil out the stack, or any other obvious failures. Exhaust diffuser vanes will appear to be "wavy" (see figure 5) when viewed from above if the turbo is subjected to an overheat/overspeed condition. Also look for a bulged turbine shroud which may also indicate an overheat/overspeed condition. The rotating assembly will be unable to turn due to elongated turbine blades from the excessive temperature and centrifugal force in which the blades contact the shroud. If the above conditions are found, the turbo will need to be replaced, and the engine will have to be inspected for conditions that may create excessive heat such as broken piston rings, worn injector tips, broken exhaust valves, improperly timed injectors, incorrect valve timing, plugged aftercooler cores, and plugged engine air filters.

Figure 5: Warped exhaust diffuser

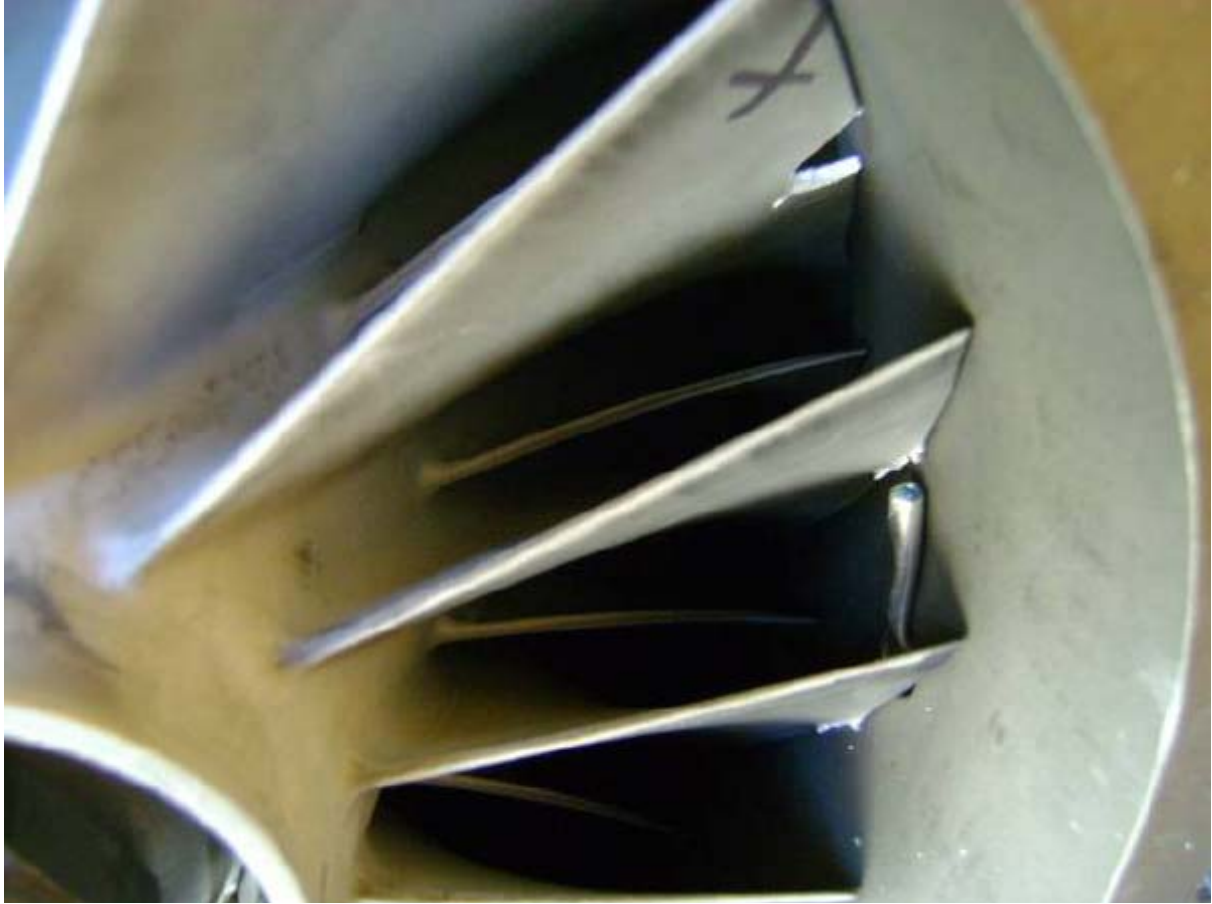
Figure 7: Temperature probe improperly installed in speed pickup hole
